Inspection Report Minerals Regulatory Program

Report Date: November 19, 2004

Mine Name: DKG Quarry

Permit number: M/015/041

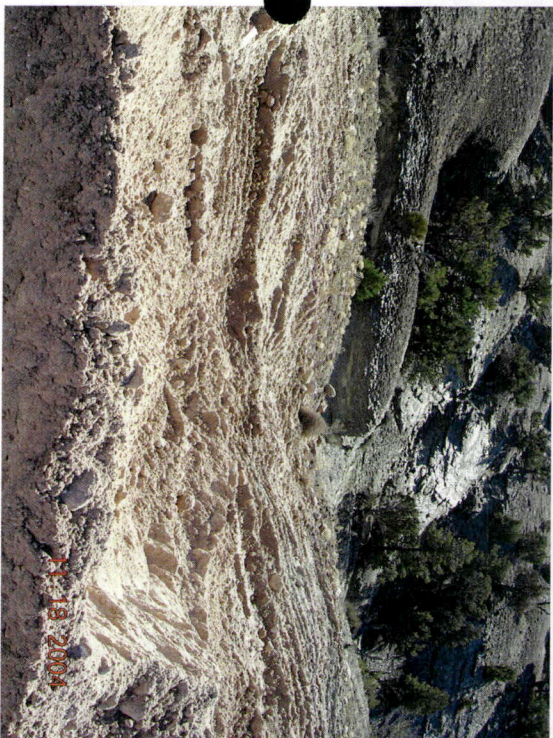
The operator mines gypsum from relatively small (about 5-10 acre) "plateaus" between more deeply eroded areas. There are several small drainages coming off the mining areas into the larger drainages. The operator is working to tie the regraded areas into these drainages (Photo 1) and should continue to do this as much as possible.

Photo 1. Regraded area being tied in to natural drainage.

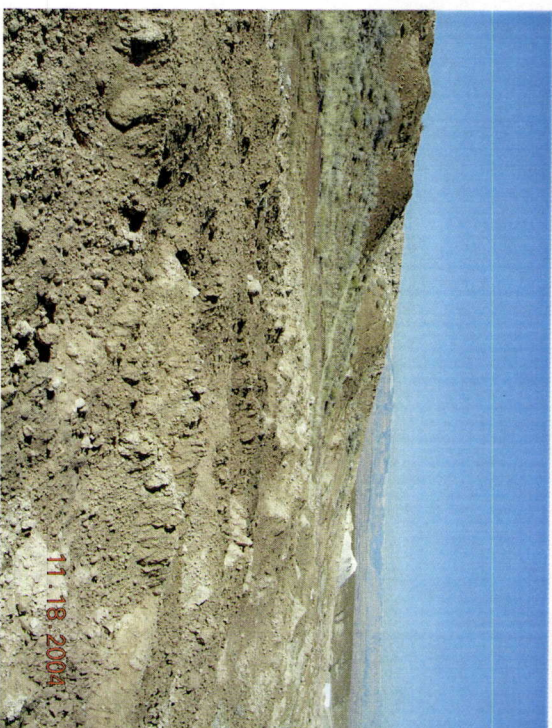
One area on the east side has been completed, including seeding (Photo 3). The operator has done a very good job roughening this area.

Photo 3. This area has been graded and seeded. Note the roughness. This should help hold the seed and water.

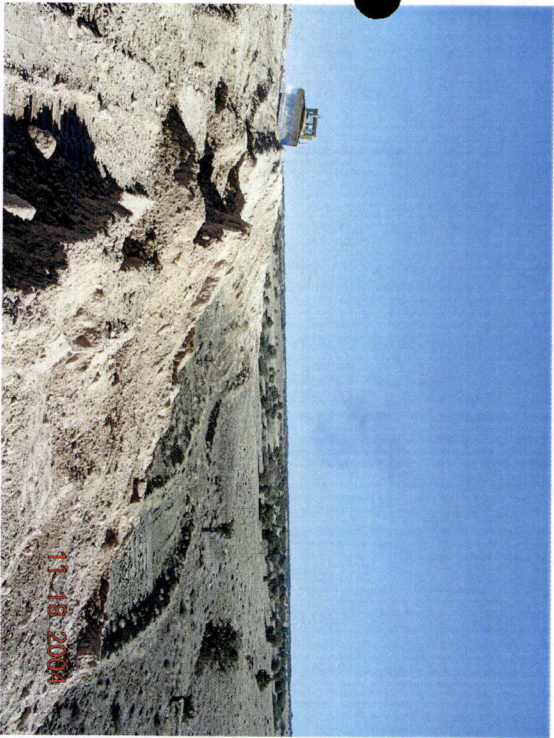
Some work will need to be done to blend the edges of the disturbed area into the undisturbed area. A specific area we discussed is shown in Photo 2. The berm on the right side of this photo is the edge of the disturbed area, and grading can be done down to this point.

Photo 2. The edge of the disturbed areas will need to be blended as well as possible with undisturbed areas.

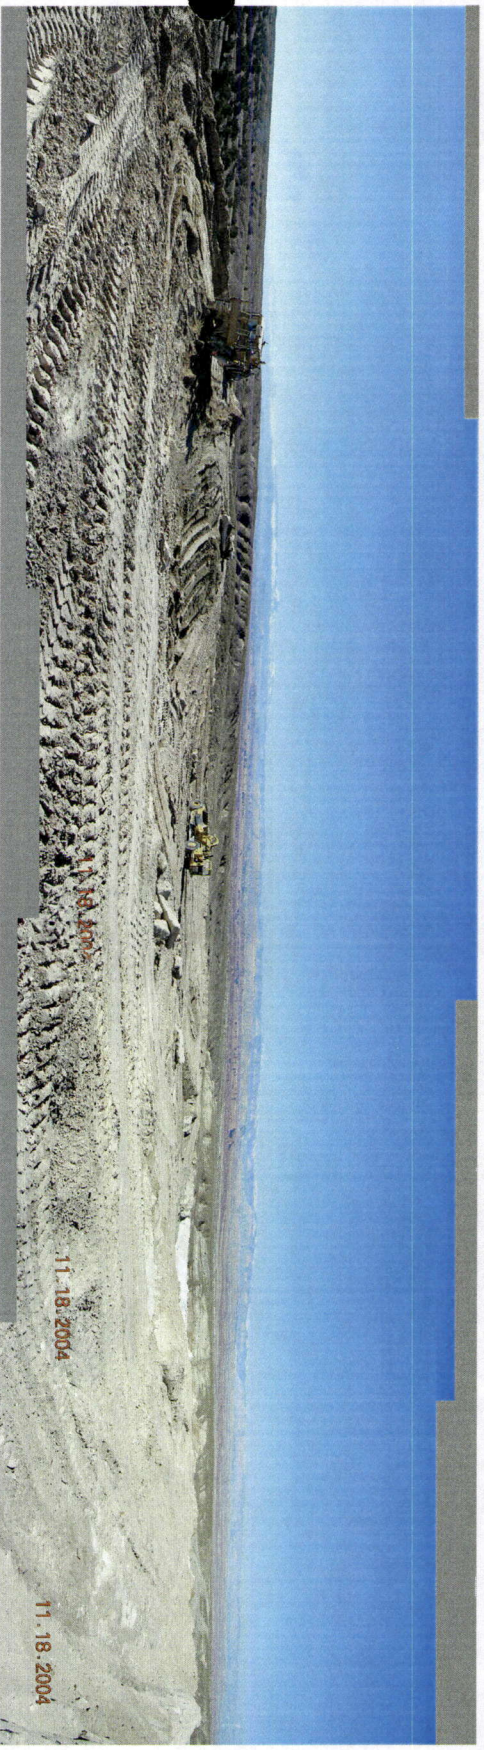
Photo 4 is a composite of four photographs and shows the main area being regraded. The grading is being done to give some variety to the terrain, and I am pleased with the work so far. The operator needs to keep in mind how water would flow and how it would get to the main drainages.

There are some large rocks on the surface (Photo 4), but anything the operator can do to also have more small rocks—sandstone, gypsum—would be beneficial.

Photo 4. Panorama of the area being reclaimed. There is some distortion in this picture.

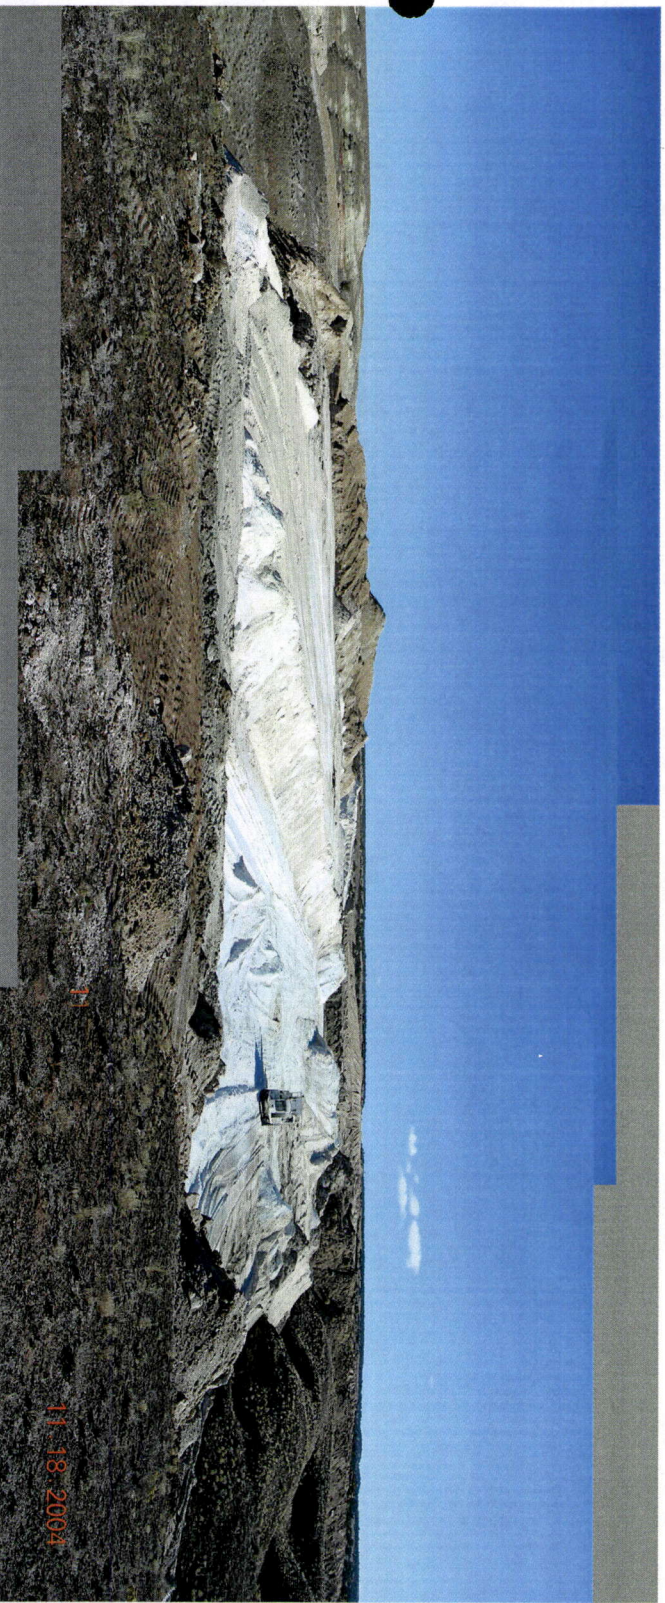
Photo 5. The active mining area. This is to the west of the area being reclaimed.
